NATIONAL REGISTER OF HISTORIC PLACES  
REGISTRATION FORM

historic name Wellscroft

street & number New York State Route 9N

city or town Upper Jay vicinity \_\_\_\_\_

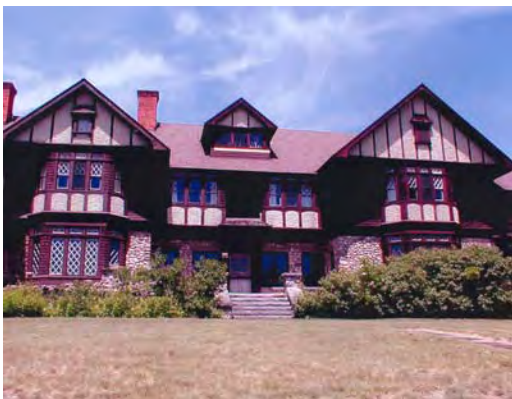
View of the front façade of Wellscroft, showing many of its exterior features.

The main house is a long, rectangular shaped two-story building with several projecting bays and porches, gables and dormers, a porte-cochere, and a service wing. The **first story** is faced with native fieldstone. This material is also incorporated into the house's porches, as roof supports and railing components, exterior stairs, and in the porte-cochere. The design and construction of this latter feature includes a crenellated parapet, buttresses, and low broad arches. Quarried local granite (anorthosite) is used for door and window lintels and sills on the first floor, porch and terrace steps, and as capstones on porch piers, railings, and on the porte-cochere's battlements and buttresses. The porches have either patterned slate or flagstone floors. The stonework of the porches and terrace is pierced by arched

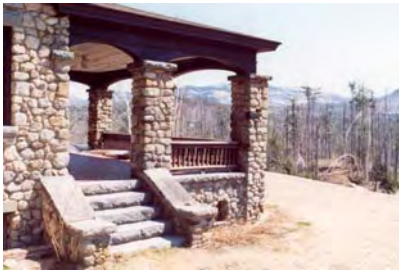
View of front porch at Wellscroft

Other notable features of the first floor exterior include a **porch** off of the barroom, a porch off of the dining room, and an open **terrace** across the front of the building, which connects the two. The porch off of the barroom is covered by a low, hipped roof, which is supported by five stone piers. Wood railings run between the piers. The porch off of the dining room is covered by the second-story sleeping porch, which is supported by four stone piers. This porch has identical wood railings. There is also a small porch off the kitchen in the service wing, which has wood

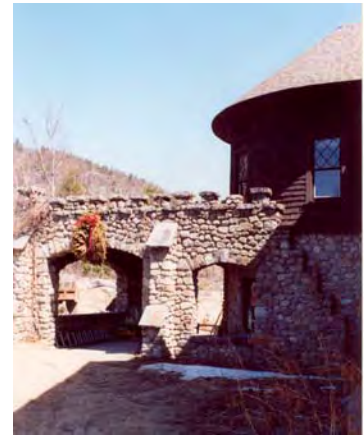
View of the porte-cochere at Wellscroft

The most distinguishing feature of the rear of the first floor is the large semi-circular projection, which houses the interior **stairway**, and the **porte-cochere** attached to it.

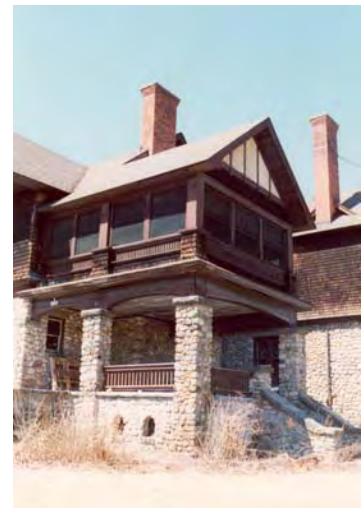
View of sleeping porch

There is a single exterior **door** from the second floor, which leads to the sleeping porch off of the master bedroom. This **sleeping porch** is above the porch off of the dining room. Its roof is supported by short, shingled piers and wood posts. It is finished with edge and center bead (wainscoting) walls and ceilings, has a painted canvas floor, and has retractable shutters for each screened opening to the outside.

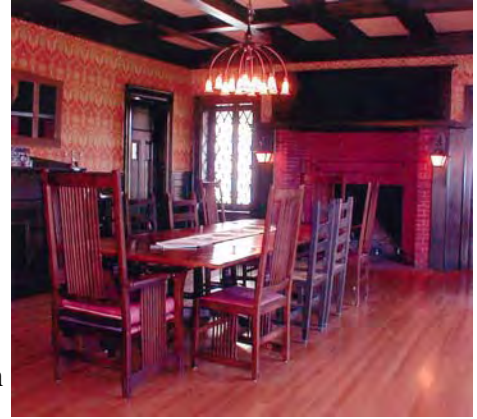
Wellscroft Living Room, showing boxed beam ceiling, fireplace, floors, and typical windows and doors.

One wall of the living room is dominated by a brick fireplace, which is 14' wide and topped by a projecting wood mantle and a paneled area above. The fireplace opening is 5' x 32" and it is faced with narrow (1 1/2") brick. The 2' deep hearth has a herringbone tile pattern. Outside light is provided by six diamond-paned, casement windows. Several of the paneled interior doors between the living room and

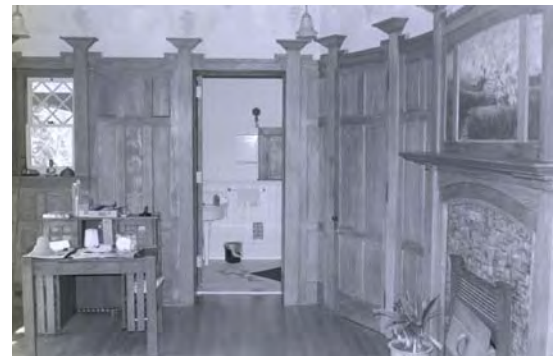
Ladies Tea Room, showing wainscoting, fireplace, wall painting, floors, and typical doors and window

The "Ladies' Tea Room" is a 13' x 17' room, just off of the living room. It has very distinctive 8' high (pickled) oak wainscoting, with a pattern of recessed vertical panels, divided by vertical wood pilasters with flared capitals. Above the wainscoting are plaster walls, on which there is a hand painted pattern of grapes and flowers, and a plaster ceiling. The woodwork also extends to the built-in seat in the bay window, to the interior doors to the closets and bathroom, and to the fireplace surround. The fireplace has a cast-iron (coal) insert, which is surrounded by mottled green ceramic tile. Above the projecting wood mantle are three panels in which a rural scene is painted. The room has 2" wide oak flooring and two storage closets, concealed in the small spaces created by the irregular shape of the room. Adjoining this room is a small bathroom, which has plaster walls and ceiling, wainscoting of 4" ceramic tiles, and 1" ceramic tile flooring.

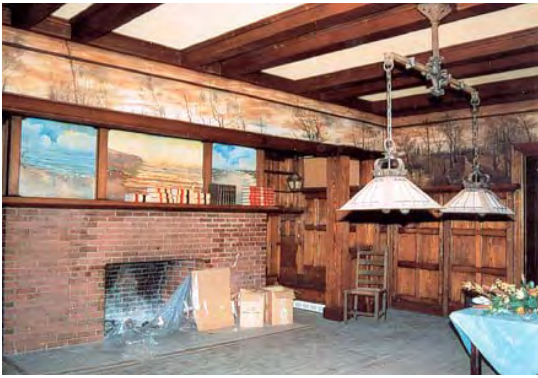
Billiard Room, showing boxed beam ceiling, fireplace, wall murals, built-in features, and original light fixtures.

The Billiard Room is a 17' 17' room, just off of the living room. Like the other rooms on the first floor, it has 2" oak flooring and a boxed beam ceiling, between which are textured plaster ceiling panels. Unlike the living room and dining room, where the beams make a grid pattern, in this room the boxed beams run across the room in pairs. The room has very distinctive (75" high) recessed panel wainscoting, which is capped by a deep ledge. All the woodwork is oak and is finished in a medium dark stain. Above the

wainscoting are plaster walls, on which a mural of an outdoor scene is (hand) painted. This painting extends around the entire room. The focal point of the room is a large brick fireplace. The fireplace mass is 11' 6" wide and the fireplace has a 52" x 34" opening and a herringbone pattern hearth. Above the fireplace mantle, in three panels, is a hand painted ocean scene. The murals were done by Lake Placid artist Averil Conwell. The billiard room also has several distinctive built-in features. On either side of the fireplace are inglenooks or built-in benches and within the nooks are built-in cupboards. Opposite the fireplace is a large (13' 6' wide and 2' deep)

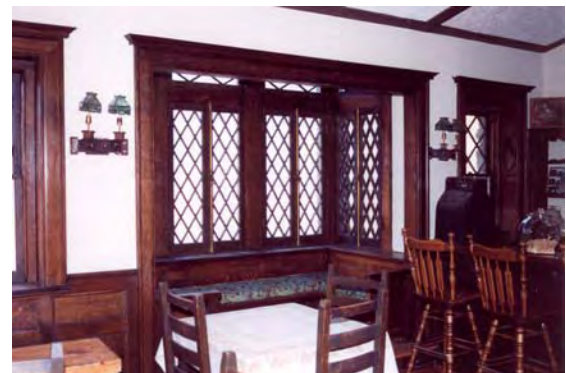
View of Barroom, showing wainscoting, window seat, and bay window.

It has 2" oak floors, (40" high) paneled oak wainscoting, plaster walls above the wainscoting, and a shallow arched plaster ceiling. Like the Ladies' Tea Room and Billiard Room, its central features are a fireplace and bay window, opposite one another. The fireplace is made of a gray brick, is 8' x 5' overall, has a 3' x 2 1/2' opening, steel insert, herringbone pattern red brick hearth, and is capped by a simple wood mantle. On either side of the fireplace are built-in cupboard units, each with a shelf unit above with clear and stained glass doors and drawers below. The window seat is 12' wide and is lit by five pairs of diamond-paned casement windows and five fixed diamond-paned windows. The room is also lit by three other double-hung windows, diamond-paned above and single light sash below. A paneled oak exterior door leads to the front porch. Of more recent vintage in the room is its bar and liquor storage unit.

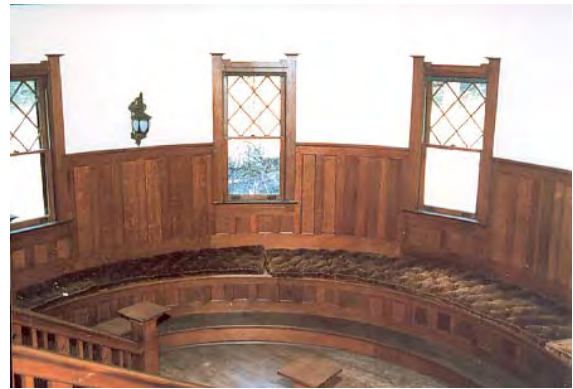
View of stairway landing, showing built-in window seat, wainscoting, and typical windows

semi-circular shaped entrance hall. In this space are a door to the cellar stairs, a storage closet, and a double doorway to the grand stairway. The stairway fills the large wing, which protrudes from the rear of the building, and which is 25' high, 27' deep, and 18' across. From the entrance hall, you rise up a set of center stairs to a landing and then ascend up either set of stairs, which rise to large semi-circular landing. This landing has a semi-circular window seat and seven double hung windows (diamond-paned above and single paned sash below). The room is rich in wood (oak) elements, including 60" high, vertical panel, wainscoting, stairs and railings, and 2" oak flooring. Above the wainscoting are plaster walls and ceiling. From the landing, a single set of stairs ascends to the second floor landing and central hallway.

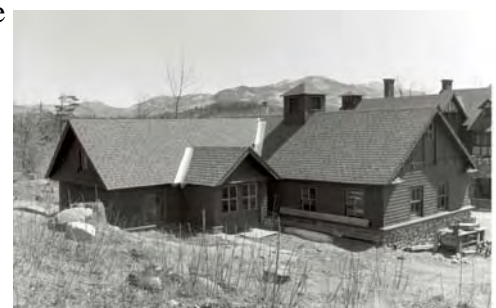
View of Power House, showing overall form and exterior features

The Power House is a (39' x 41' overall) one-story, L-shaped, building with a moderately pitched gabled roof, which is punctuated by a chimney and ventilator cap. The lower portion of the building is constructed of native field and cobblestone and the upper portion of the building is wood-framed and faced with wood shingles. The gable area of the building originally had a decorative half-timbered finish (wood and stucco), which has since been removed (plans are to restore it). The fascia of the gable eaves wood shingled. The building has several exterior wood doors, which have a four-pane light over two vertical or three horizontal panels. The building has an assortment of 2/2 double-hung windows. The Power House is used to house the wood-fired heating system for the main house, for storage and for shop space.

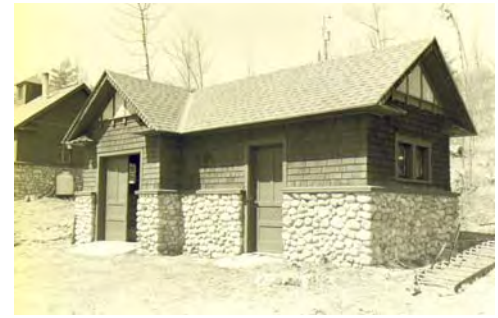
View of Fire House, showing overall form and exterior features

The Fire House is a small (17' x 27' overall) one-story, T-shaped, building with a moderately pitched gabled roof. The lower portion of the building is constructed of native field and cobblestone and the upper portion of the building is wood-framed and faced with wood shingles. The gable portion of the eaves are also shingled. The gables have decorative half-timbering (wood and stucco). The building has several exterior wood doors, which have four (two vertical over two horizontal) panels. The building has an assortment of four pane casement windows.

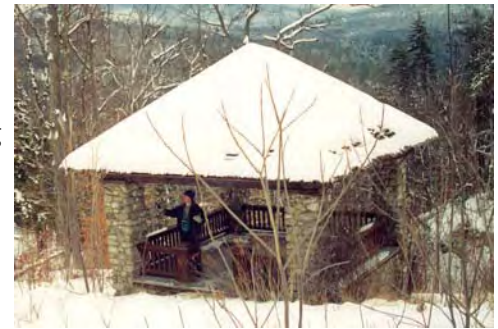
Wellscroft Gazebo, showing exterior features

The Gazebo is a square open structure, approximately 16' x 16'. It has a field and cobblestone-faced foundation, a hip roof supported by four field and cobblestone corner piers, and a wood floor deck, between which are wooden railings.

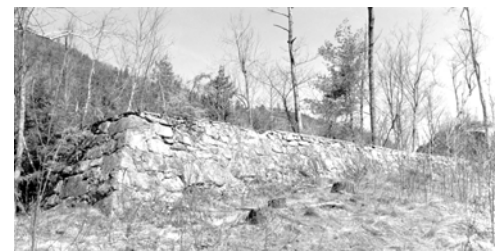
Reservoir at Wellscroft, showing stone walls

The original property also had two reservoirs, which were part of an extensive water supply and fire protection system and which also included a series of fire hydrants, several of which are extant. The reservoirs are large, open, rectangular stone structures, the insides of which are parged with concrete. Although only in fair condition, they are still intact and retain a high degree of their integrity. The Root Cellar is an underground structure, constructed of native fieldstone. It has a barrel-vaulted ceiling and is accessed via a corridor cut into the embankment, which is supported by two stone retaining walls. It has one wood door.

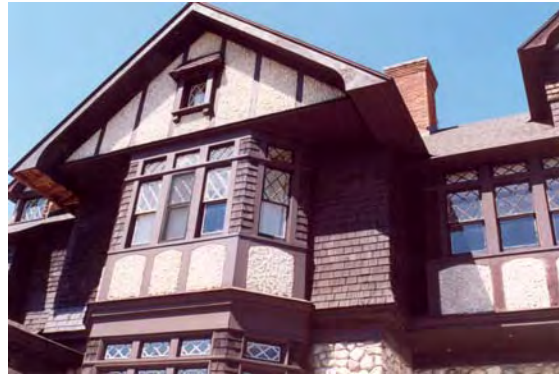
Detail of Wellscroft, showing some of its Tudor Revival details - half-timbering, cross gables, stonework, wood shingles, and large chimneys

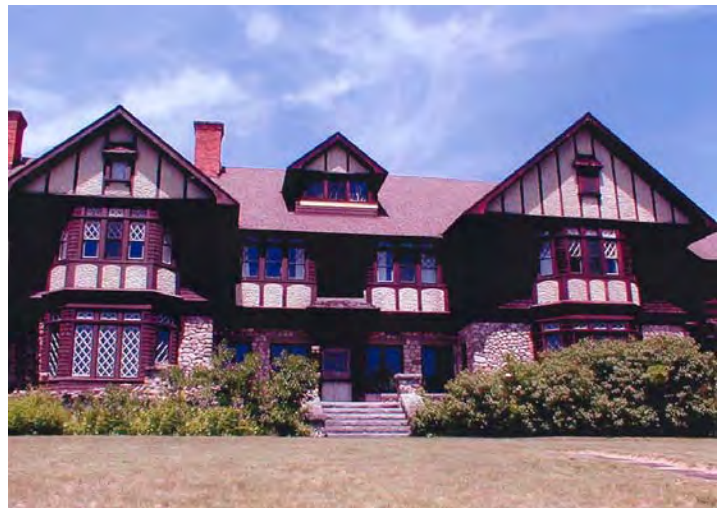
Front façade of Wellscroft, showing many of its Tudor Revival style features, including projecting bays and cross gables, stone, wood shingles, and half-timbering, moderately pitched roofs, narrow casement windows, and large chimneys

The main house is a long, rectangular shaped two-and-one-half story building with several projecting bays and porches, gables and dormers, a porte-cochere, and a service wing. The first story is faced with native fieldstone, which is also used on the house's porches, as roof supports and railing components, on exterior stairs, and in the porte-cochere. Quarried local granite is used for door and window lintels and sills on the first floor, porch and terrace steps, and as capstones on porch piers, railings, and on the porte-cochere's battlements and buttresses. The porches have either patterned slate or flagstone floors. The stonework of the porches and terrace is pierced by arched openings to allow for ventilation. This widespread use of stone is an important attribute of Tudor Revival style architecture and goes back to an embrace of the "medieval" and to the use of materials which were both simple, natural, and "rugged."

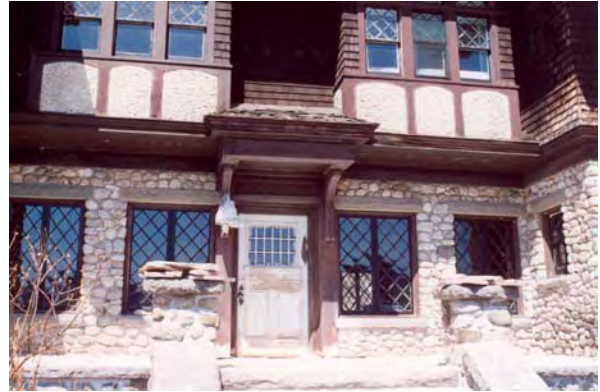
Detail of Main House, showing window, door, and other façade details

The exterior of the main house is punctuated by an assortment of casement, fixed, and double-hung windows. The casement windows are tall and narrow, have diamond-paned sash and occur as single units, in pairs, and as groups of three or more units in the building's bay windows. The double hung-windows, primarily found on the service wing, typically have diamond-paned sash above and a single light below. The diamond-paned sash is another direct reference to medieval building details.

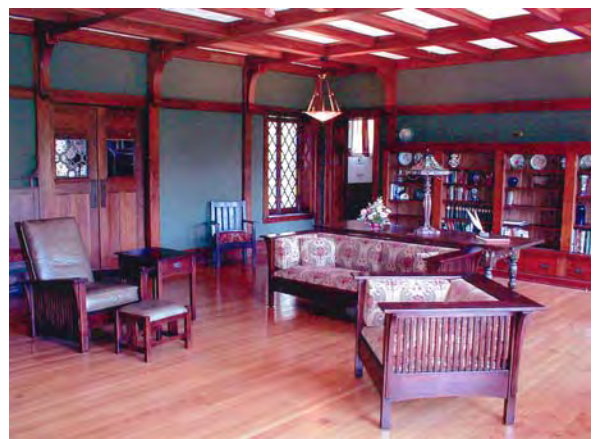
Living Room at Wellscroft, showing many of its Arts and Crafts style features

The interior of Wellscroft displays many of hallmarks of the Arts and Crafts style, including: the widespread use of wood in floors, doors, decorative trim, box beamed ceilings, wainscoting, fireside nooks, window seats, and built-in furnishings.
